The Rihand Dam

Sonebhadra, Uttar Pradesh, India

Project Type
DAMS

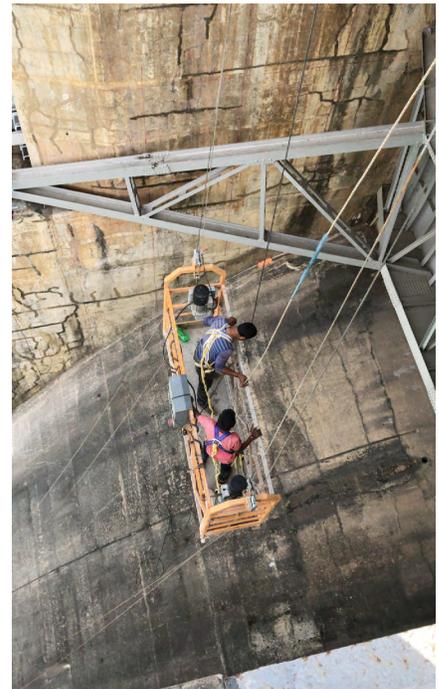
The spillways suffered deterioration of the concrete surface, structural cracking as well as spalling at the crest.

In the spillway, cracks and construction joints were chipped out as per the specification to repair it with a first layer of [Xypex Patch'n Plug](#) followed by a second layer of [Xypex Megamix II](#). Nozzles were also fixed along the cracks, construction joints and honeycombed concrete which were grouted with a specified mix of [Xypex Admix C-2000 NF](#), cement and fine silica.

Xypex Megamix II was then applied to the entire surface of the spillway and a two coat application of Xypex Concentrate was applied to the mortar repaired surface to provide extra protection.

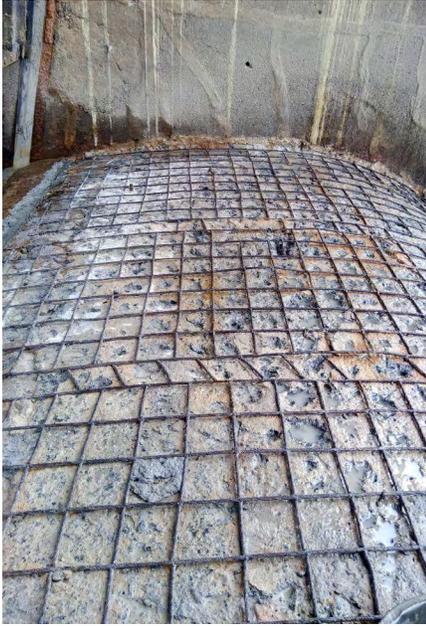
Significant Spalling

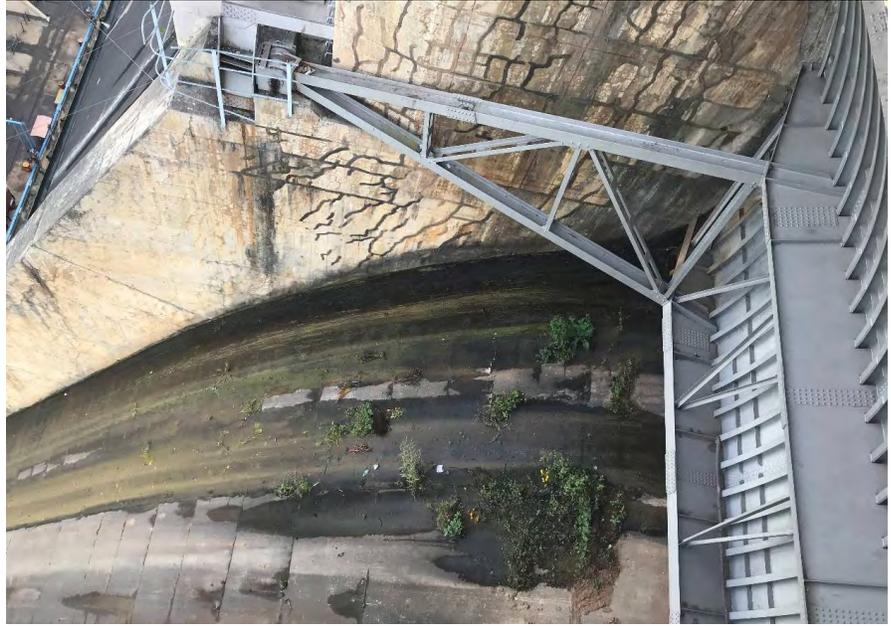
Alligator cracking in the piers indicated the occurrence of AAR.

The same technique was used in both the piers and the top of the dam. A total of 57,000 kg of Xypex Patch'n Plug were used to repair cracks and joints. Xypex Megamix II was applied at a thickness of 12.5 mm to resurface 14,000 m² of deteriorated concrete surface. Xypex Concentrate was applied to an area of over 21,000 m² to provide final protection to the concrete.

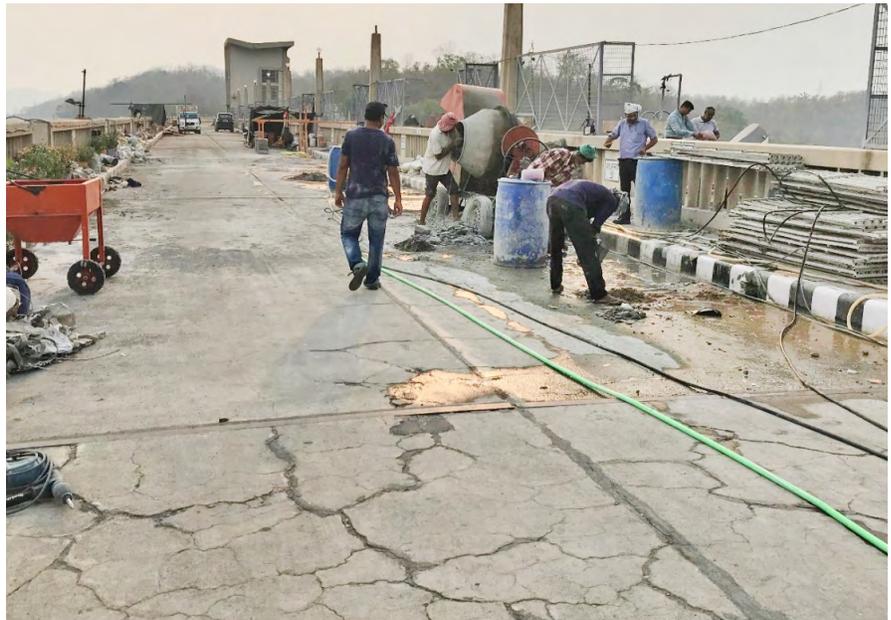
The top of the dam showed severe deterioration.

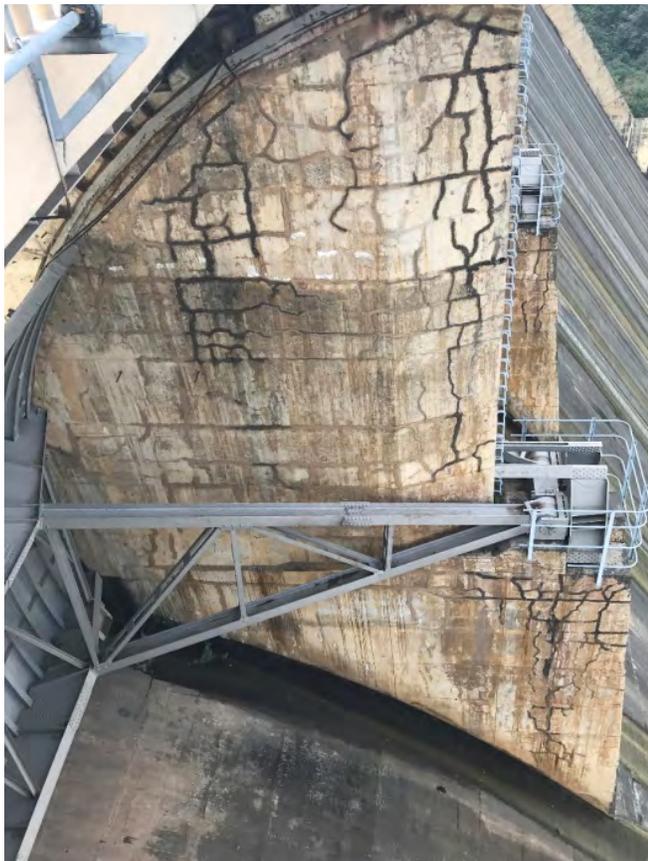
Pier before repair

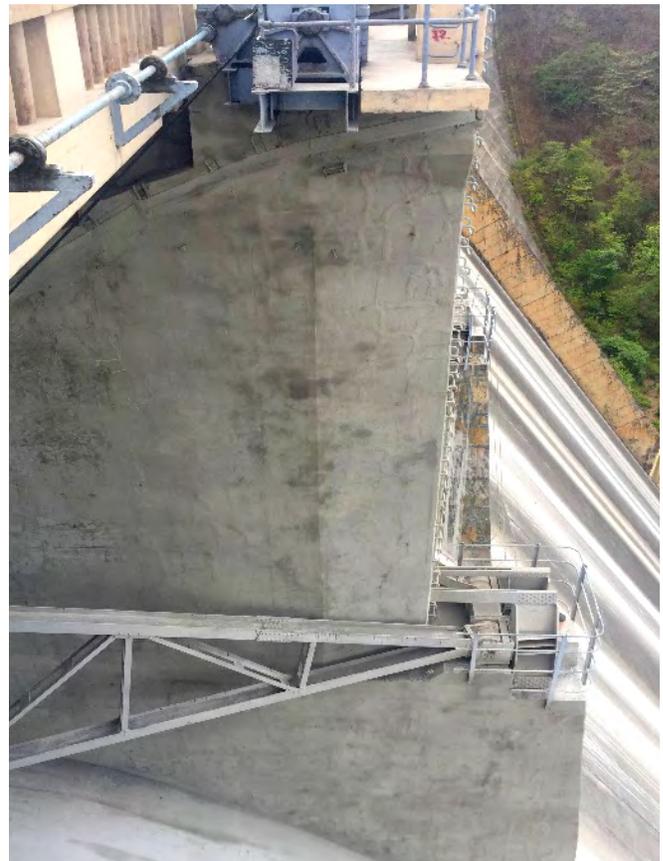
Pier after repair
